# An Assessment of the Use of Structural Deformation as a Method of Determining Area of Fire Origin

# AN ASSESSMENT OF THE USE OF STRUCTURAL DEFORMATION AS A METHOD OF DETERMINING AREA OF FIRE ORIGIN

Andrew T. Tinsley, CFEI, EIT University of Tennessee, USA and David J. Icove, Ph.D., P.E., CFEI University of Tennessee, USA

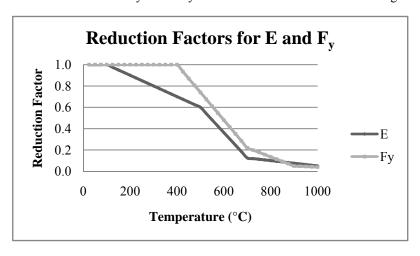
The variation of the modulus of elasticity and the yield stress of steel can be found in Figure 1 below.

Figure 1: Reduction Factors

This simple equation was set up into a spreadsheet in order to show the general deflection behavior under an increasing thermal loading with no increase in gravity loading. This calculation utilizes the yield stress and modulus of elasticity reduction factors shown in Figure 1. Deflection is mainly a function of the modulus of elasticity. Figure 4 shows the increase in deflection with temperature, and Figure 5 shows the decrease in nominal moment capacity with temperature.

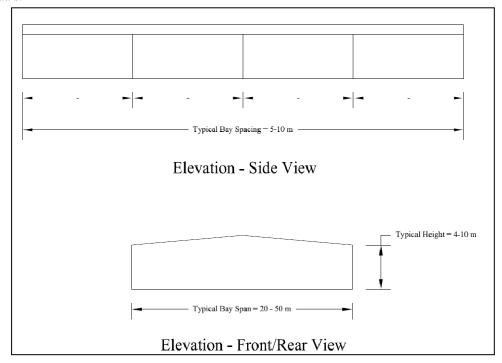
According to Buchanan, portal framing systems are typical in large warehouses as well as in commercial establishments and are one of the more prevalent steel building types.<sup>3</sup> They are fairly simple to design and even easier to construct. Figure 2 shows an elevation view of a typical portal framed structure. They are widely adaptable since the bay lengths or clear spans can be adjusted with the use of larger structural members to suit the needs of the tenant. Portal frames were chosen for this analysis because of their frequency of use as well as their simplicity to analyze by non-engineering background individuals.

Figure 2: Typical Portal Frame Dimensions

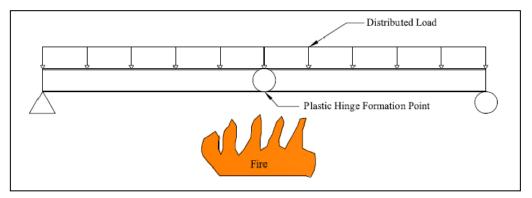
Steel design intends to insure that the steel remains in the elastic behavior range under service loads. This is to say that the steel has yet to yield. When fire degrades the structural capacity of a member, the member can quickly enter into the plastic range on the elasticity curve. When this happens, the loading must be redistributed. In the case of a simple beam, this redistribution will not occur since it has no redundancy. Figure 3 below shows the failure mechanism of a simply supported beam along with the general shape of the moment diagram before and after the formation of the plastic hinge at the center.

Figure 3: Failure Mechanism of Simply Supported Beam

The deflections stop at approximately 600 °C. At that point, this particular beam undergoes plastic deformation and for all practical purposes has failed. In other words, the deflection will increase greatly with no increase in loading since the steel has yielded. Therefore, it can no longer take any additional loading. As can be seen in these figures, the steel has lost its ability to retain the design moment at approximately 400 °C (750 °F). At this particular loading, the beam is expected to fail at approximately 600 °C (1000°F), or when the steel yields. The failure mechanism of a simply supported beam (or bar joist, purlin, or any other simply supported moment resisting member) is demonstrated in Figure 3 on the previous page.

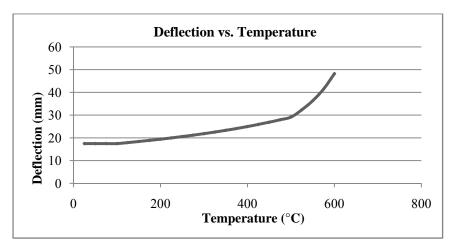
Figure 4: Simply Supported Beam Deflection Behavior under Temperature Loading. Note that the Beam Enters Plastic Deformations at Approximately 600 °C.

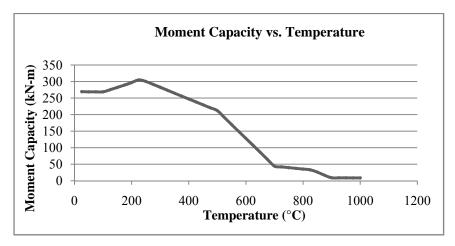
Figure 5: Simply Supported Beam Moment Capacity vs. Temperature.

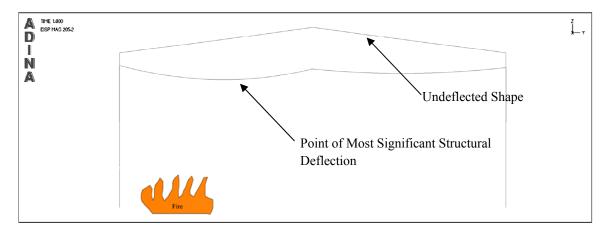
A simple finite element model was constructed to show the deformations undergone by a building depending on the origin of the fire. Several modeling conflicts prevented a coupled analysis from being performed. The thermal portion of the model was performed to attain the temperatures of the specific members in the cross section of the portal frame. The degraded modulus of elasticity and yield stress were then imported into a structural model to get the general deflected shape. The member sizes and criteria are not important in this run of models as the purpose is to obtain general deflected shapes. ADINA was used for all finite element modeling. Figures 6 and 7 show the deflected shape with respect to the area of origin of the fire. Also note that the lowest area is not always the area with the most deflection. The most deflection is the point on the frame that has translated from its original position the most.

Figure 6: Fire on One Side of Building

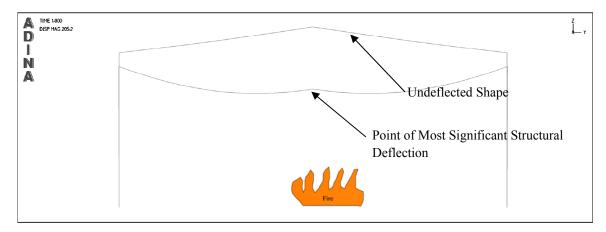
Figure 7: Fire Under Peak of Roof

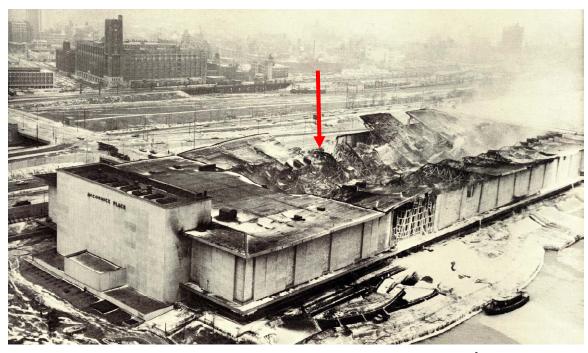
There are several examples where the use of structural deformations would have significantly shortened the investigation time. While in most cases deformations are noted as a viable indicator, it is rarely used as evidence in an investigative report. The McCormick Place fire in Michigan as well as the Livonia Transmission Plant fire both consisted of a more complicated version of the portal frame design/construction method. Both fires consisted of total destruction of the buildings. Both had witnesses to confirm the area of origin of the fire, so validation of the use of the structural deformations was possible. Figures 8 and 9 show the deformed shapes of McCormick and Livonia, respectively, and their confirmed area of origin.

Figure 8: McCormick Place Collapse and Confirmed Area of Origin<sup>5</sup>

By starting at the areas of partial collapse and high deformation, the investigators would have been able to disregard a lot of the fire debris and had a much easier time finding the area of origin if there had not been

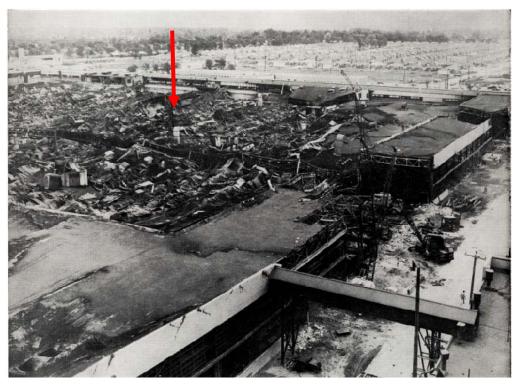
Figure 9: Livonia Transmission Plant Partial Collapse and Confirmed Area of Origin<sup>6</sup>

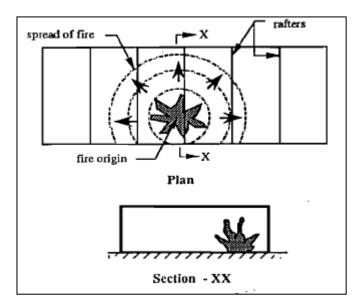
Figures 11 and 12 show a typical fire scenario in a portal frame constructed building. Figure 9 shows a plan view of the scenario. It shows a fire beginning slightly off center and spreading in a radial fashion throughout the structure. While the fires are not located in exactly the same place, Figure 10 shows the probable after fire scenario once it was stopped. The red arrow indicates the probable area of origin. With proper use, this method of investigation can yield much valuable information about the investigation at hand. This information can vary from significantly reducing the amount of time digging in the rubble of a fire to valuable input for an advanced forensic model. The intricacies of this method should be left up to

Figure 11: Plan View of Fire within Portal Frame Structure<sup>7</sup>

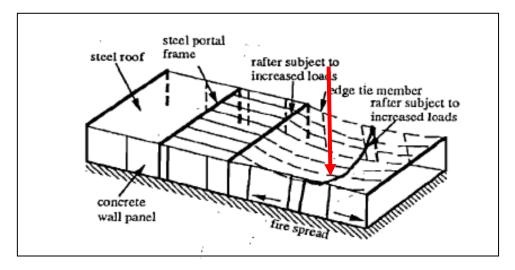
Figure 12: Isometric View of Probable Failure Mode of Portal Framed Structure. Note the addition of the probable area of origin (Red Arrow).
